2010 Chile earthquake: science and insurance also evolving

The 8.8 magnitude Maule, Chile, earthquake Seismological review and field survey observations

John E. Alarcon
MEng (Civil Eng), MSc, PhD DIC
Research Associate
AIR Worldwide (London, UK)

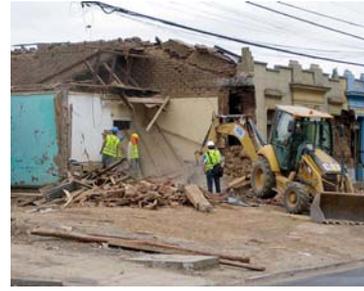
In terms of damage to non-insurable buildings, an example of their structural behaviour was observed in the historical centre of Talca, the capital of the Maule Region. Here, residential buildings were predominantly made of adobe. About 1,500 adobe homes were either destroyed or were undergoing demolition at the time of the survey (Figure 6). These dramatic effects on adobe houses were also observed during the 2007, Pisco, Perú earthquake (Alarcon et al., 2008), highlighting the extreme vulnerability of unreinforced adobe to the lateral forces induced by the earthquake.

Figure 6. Collapse and demolition of adobe brick structures in Talca
(Source: AIR)

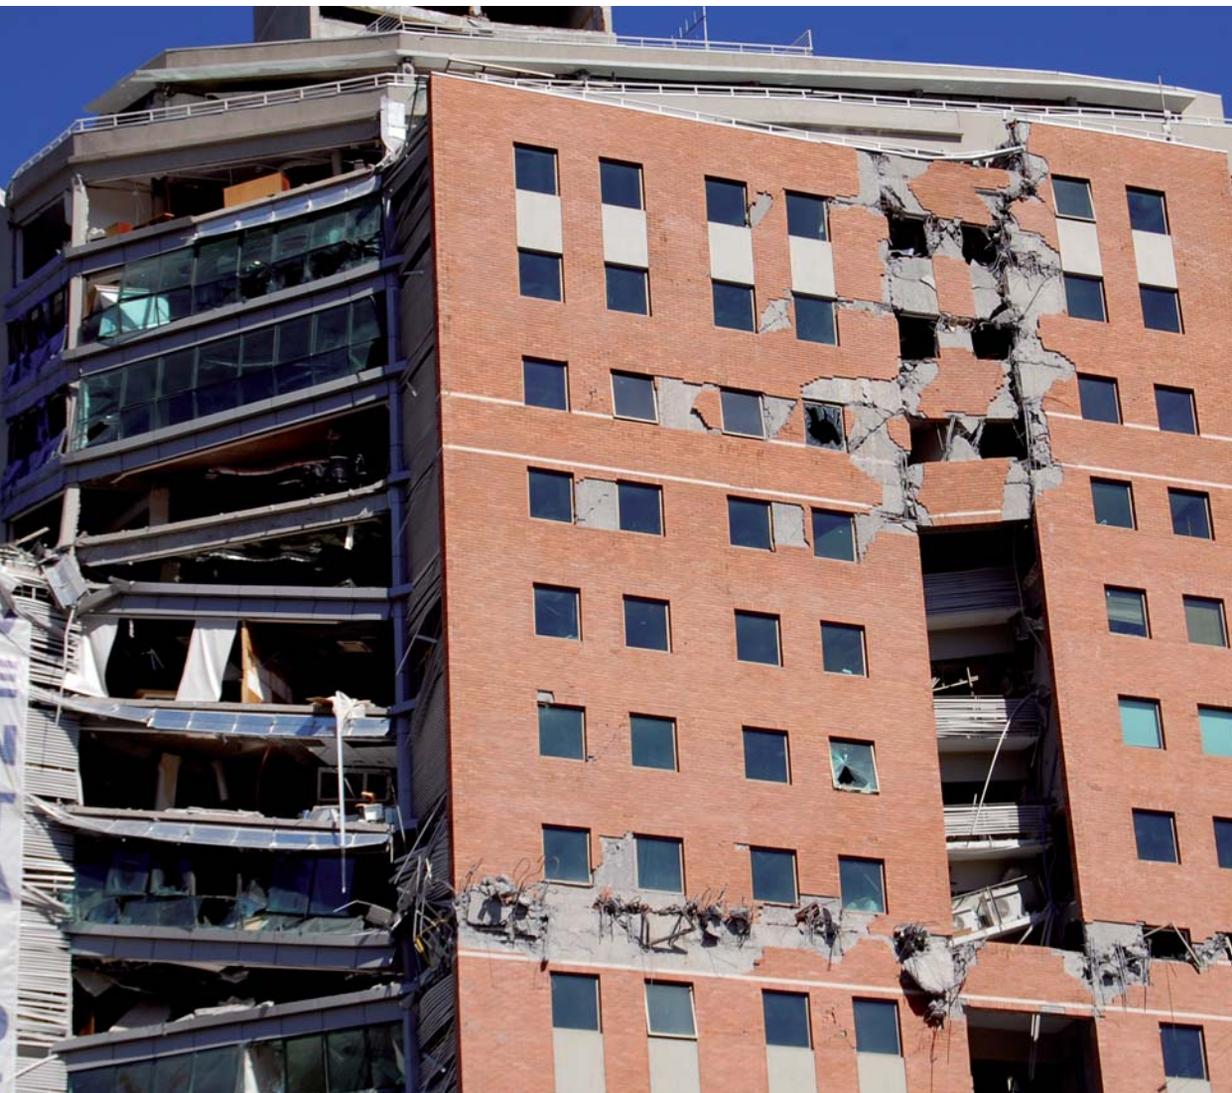
Figure 7. The Torre O'Higgins in Concepción

Figure 8. Fully collapsed building located in Concepción
(Source: AIR)

where several structures will have to be demolished due to partial collapses at localised floors. At the time of the visit, the city's municipality considered that a total of eight buildings had to be torn down, while an additional 48 would require in-depth inspections to assess whether they can be repaired. Currently, the number of buildings scheduled for demolition has generally increased, including those buildings that suffered severe although localised damage to their structures.

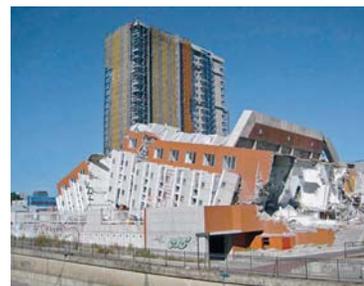
Although detailed studies are underway to discern the precise reasons why some modern structures failed in this earthquake, based on field observations it seems that the lack of vertical regularity might have been a key driver.

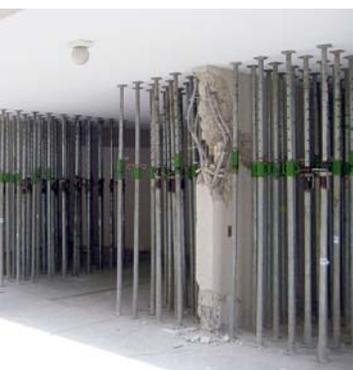
In Chile, engineered buildings significantly rely on shear walls. These are massive reinforced concrete walls within the structure that are designed to resist a large proportion of the lateral forces imposed by an earthquake. Much of the modern building stock performed well, but there were

exceptions where buildings suffered a partial collapse of concrete shear walls (Figure 9). Inspection of the longitudinal reinforcement of the walls suggested that the steel bars had suffered buckling due to excessive compressive stresses at the edges of the walls and due to insufficient confinement of the concrete. The confinement of the concrete at the edges of shear walls is typically known as a "boundary element" and it provides the wall with a higher capacity to resist earthquake loads. The absence of these boundary elements may have been largely responsible for the failure of vertical elements (see Figure 10).

Figure 9. Partial collapse of shear walls
(Source: AIR)

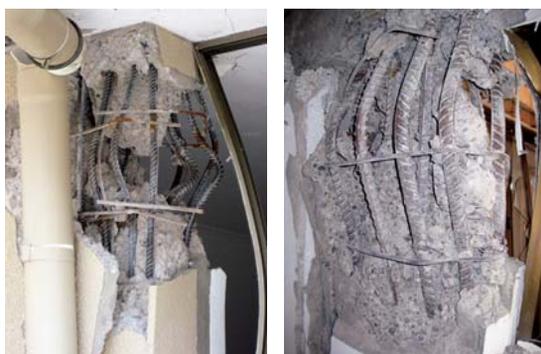
Figure 10. Large buckling of the vertical reinforcement bars exacerbated by the lack of enough lateral, or confinement reinforcement
(Source: AIR)

One such exception is related to not having fully implemented the US code concerning boundary elements in shear walls. This decision was made due to the historical practices of building strong and large cross-section vertical walls that had performed excellently in past events. However, this lack of boundary elements in conjunction with the continuous reduction of the cross-sectional

area of walls for architectural reasons has been pointed out during the analysis of this event as one of the potential causes of the damages observed to the modern building stock.

Chile has been quick to react to the lessons learned from the Maule earthquake (Franco and Siembieda, 2010). One of the most salient examples is a new draft for the amendment of the building code that revises the implementation of boundary elements, as well as increases in the design demands. The draft is scheduled for final governmental approval soon.
