The Canterbury Earthquake Sequence of 2010-2011, New Zealand: a review of seismology, damage observations and consequences

Dr. Kelvin Berryman
PhD, Manager, Natural Hazards Research National Platform, GNS¹
Science

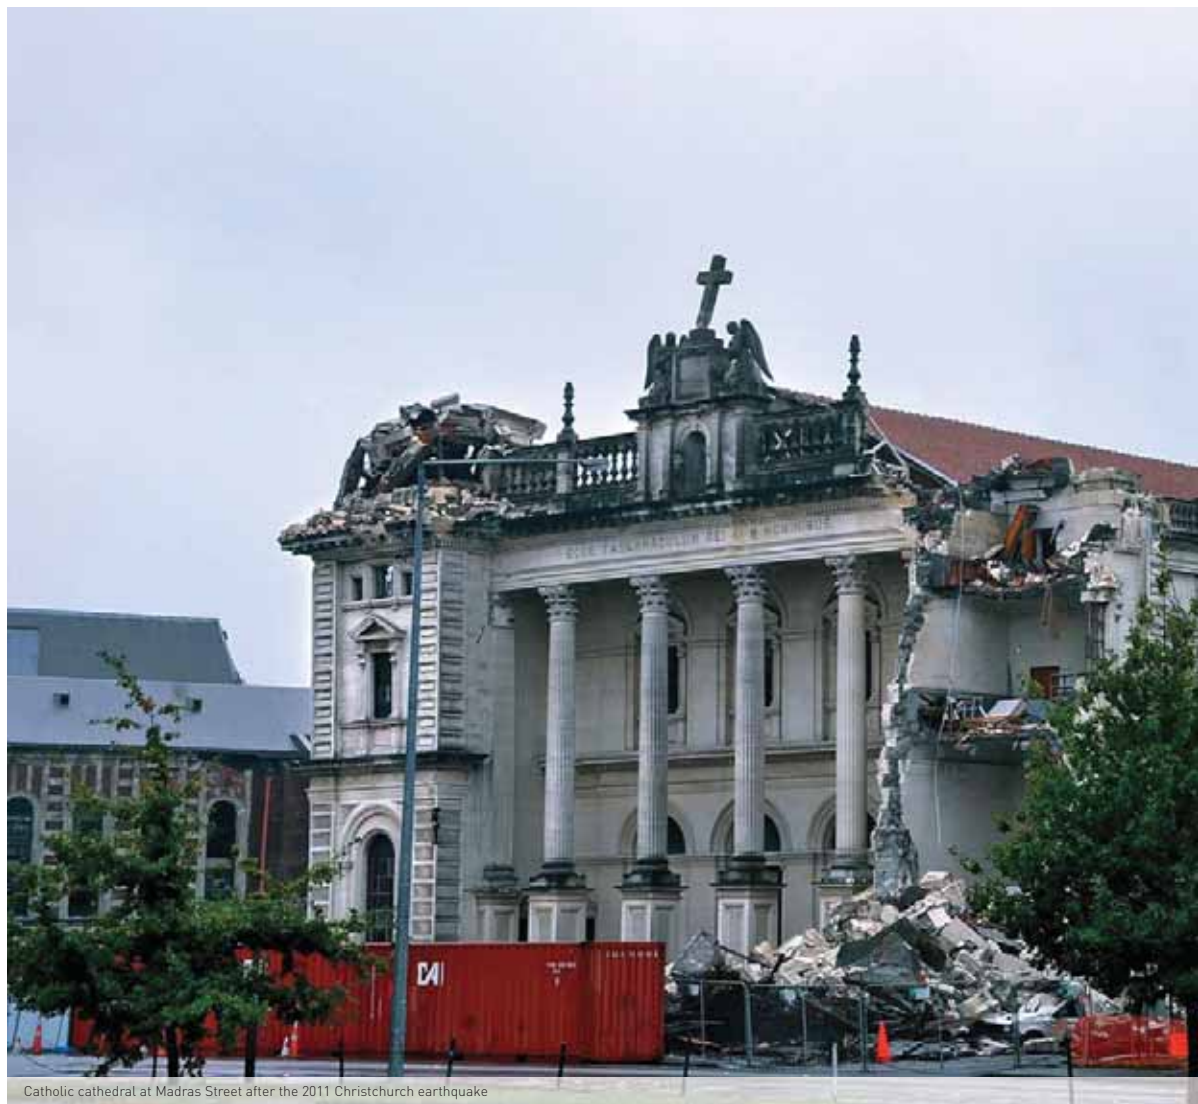
Catholic cathedral at Madras Street after the 2011 Christchurch earthquake

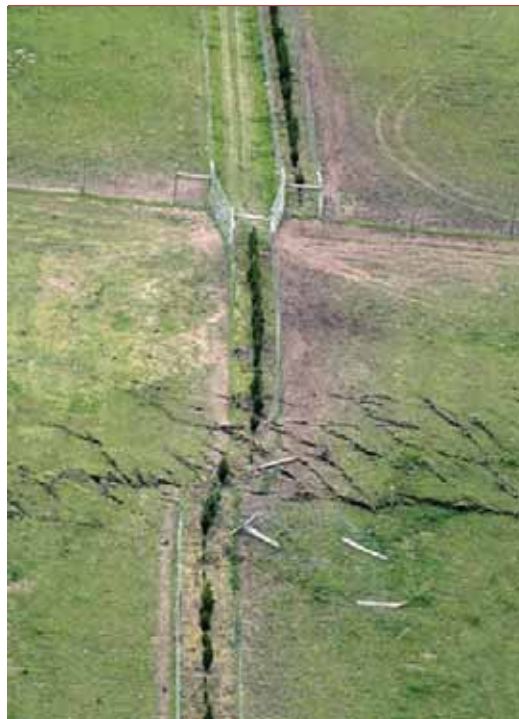
Figure 5: Example of farm fences displaced by surface rupture of the Greendale fault during the 4 September 2010 Earthquake. (Photo: Nicola Litchfield, GNS Science).

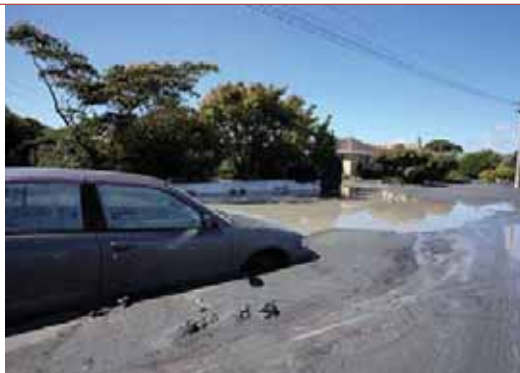
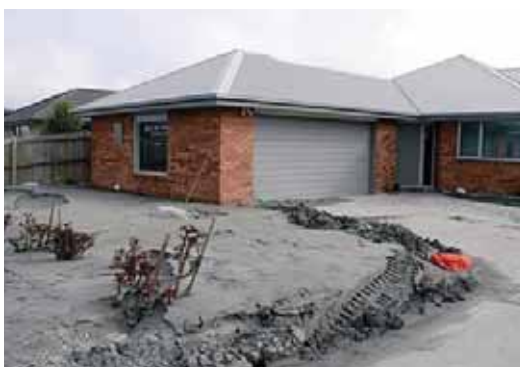
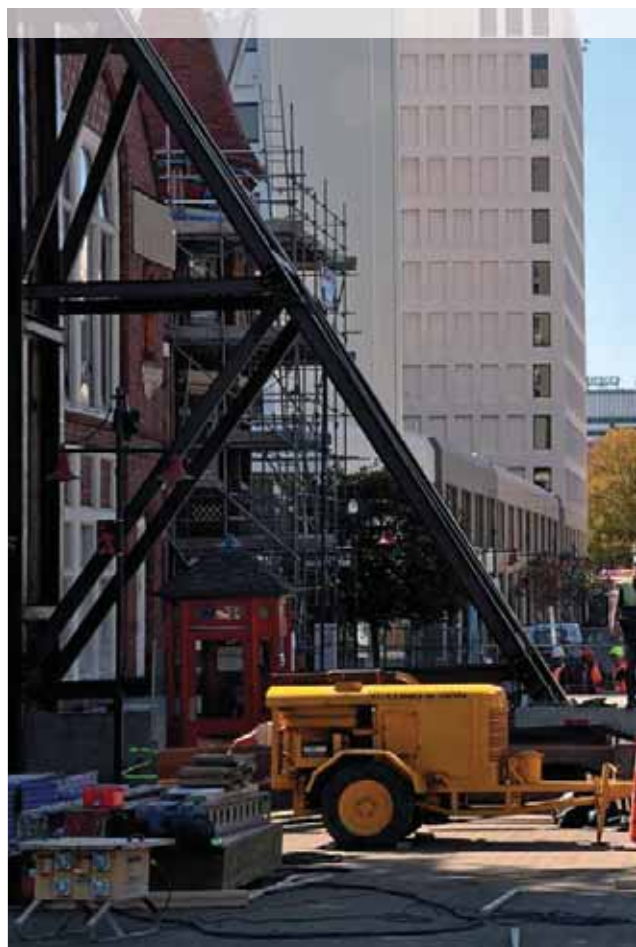
Figure 8: Liquefaction deposits in eastern Christchurch resulting from the 22nd February. Christchurch earthquake. Removal of this material has resulted in a significant land level lowering with respect to sea level and the water table. (Photos: Tonkin & Taylor Ltd).

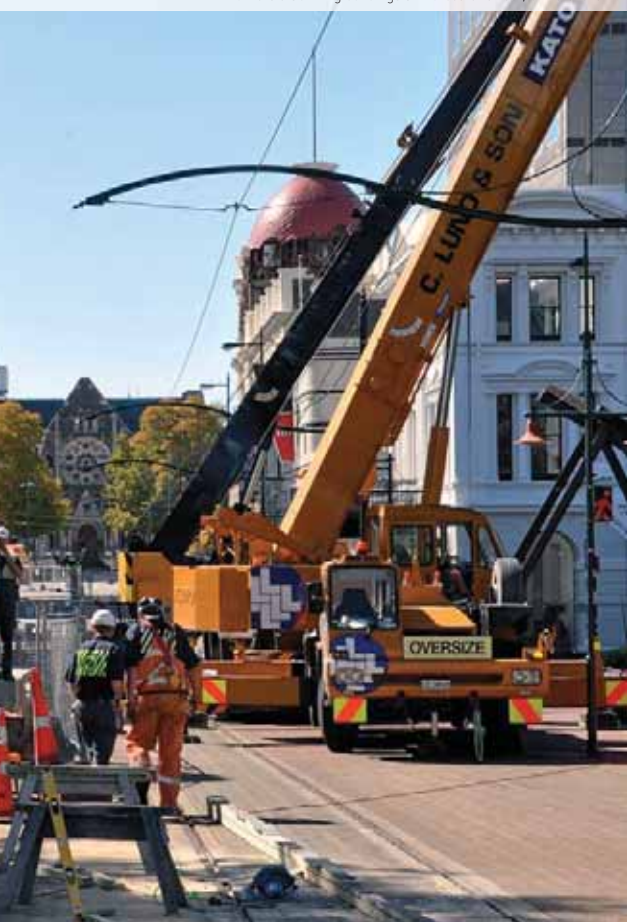
Workers stabilizing buildings at Worcester street, Christchurch

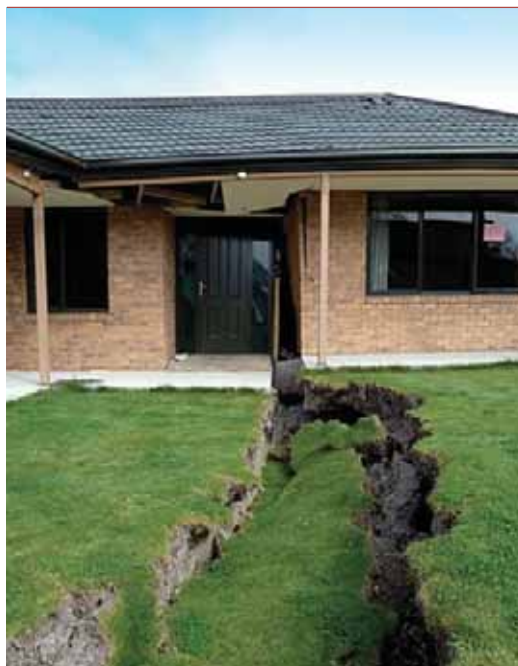
services, and to foundations of multi-story buildings in the CBD has often resulted in a total loss (Figure 10).

Figure 10: Example of a total loss of a residence in the eastern suburbs due to lateral spreading (left). (Photo: Tonkin & Taylor Ltd).

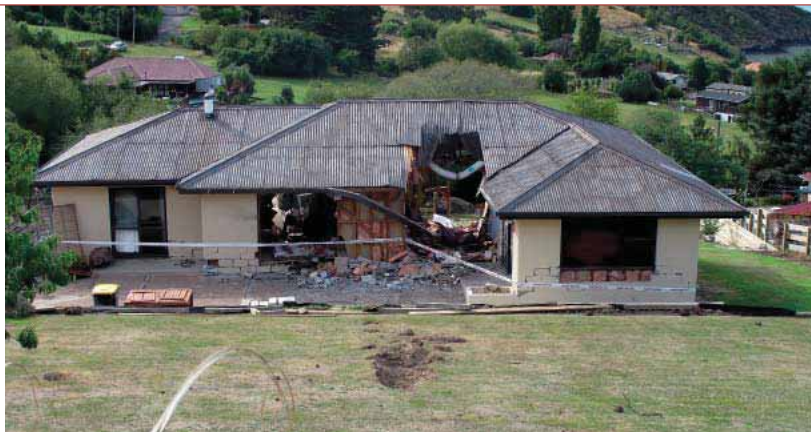
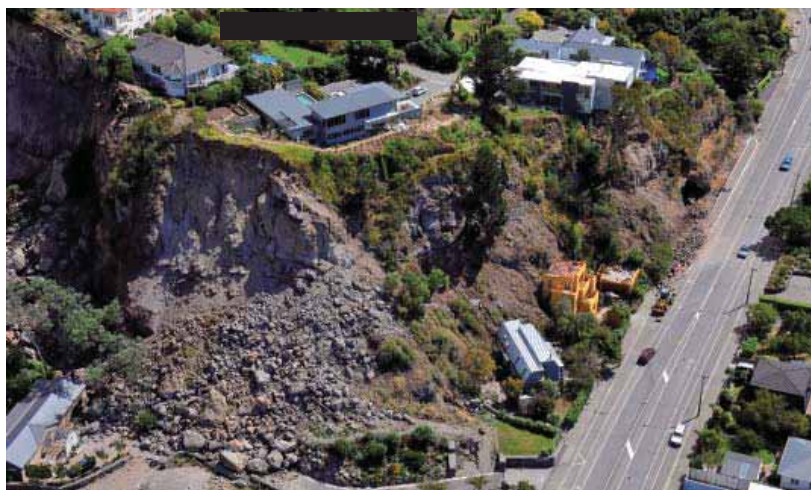
At least 100 boulders triggered by the 22nd February earthquake hit houses and there was extensive cliff collapse (Figure 11). As a consequence, about 450 residential properties in the hillside suburbs were issued with “red placards”, meaning they were assessed as too dangerous to occupy. Further boulders crashed down the slopes and hit houses, and further cliff collapse occurred during the 13th June 2011. Currently a risk assessment is being undertaken to establish tolerable or intolerable life risk to the occupiers of the “red placard” houses measured against the probabilistic earthquake shaking model. Quantitative assessment will determine

Figure 11: Example of boulder impact on house in the hillside suburbs (note the bounce mark in the foreground) (up), and cliff collapse threatening houses and occupants at both the top and base of the cliff (down).

whether retreat is necessary, whether properties can be re-occupied after cost-effective slope remediation, or establish that it is already safe to re-occupy the properties.

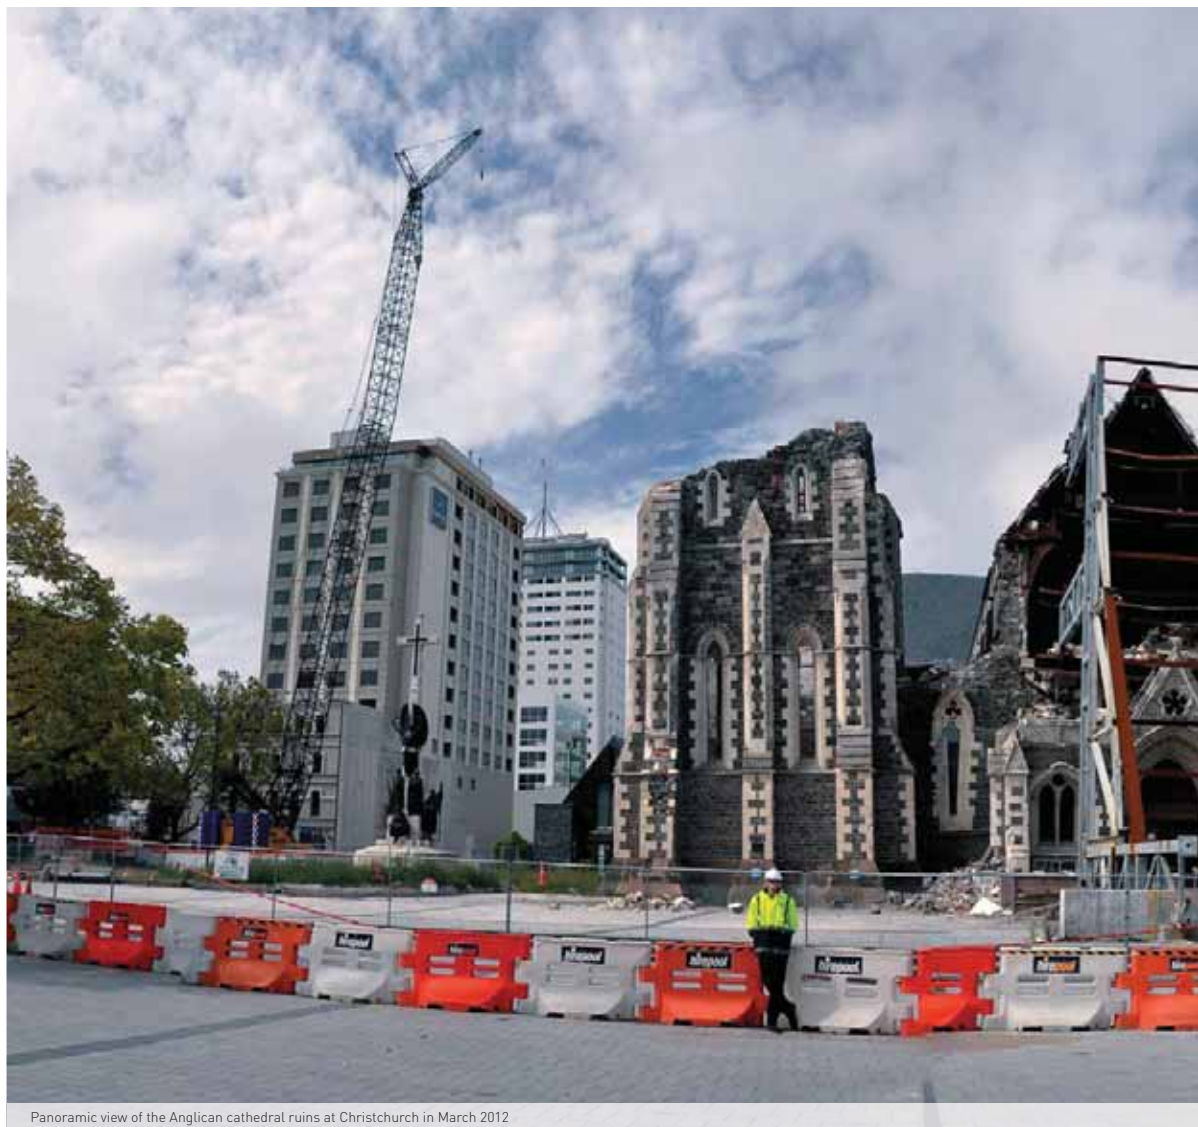
Panoramic view of the Anglican cathedral ruins at Christchurch in March 2012
