The Canterbury Earthquake Sequence of 2010-2011, New Zealand: a review of seismology, damage observations and consequences

Dr. Kelvin Berryman
PhD, Manager, Natural Hazards Research National Platform, GNS¹
Science

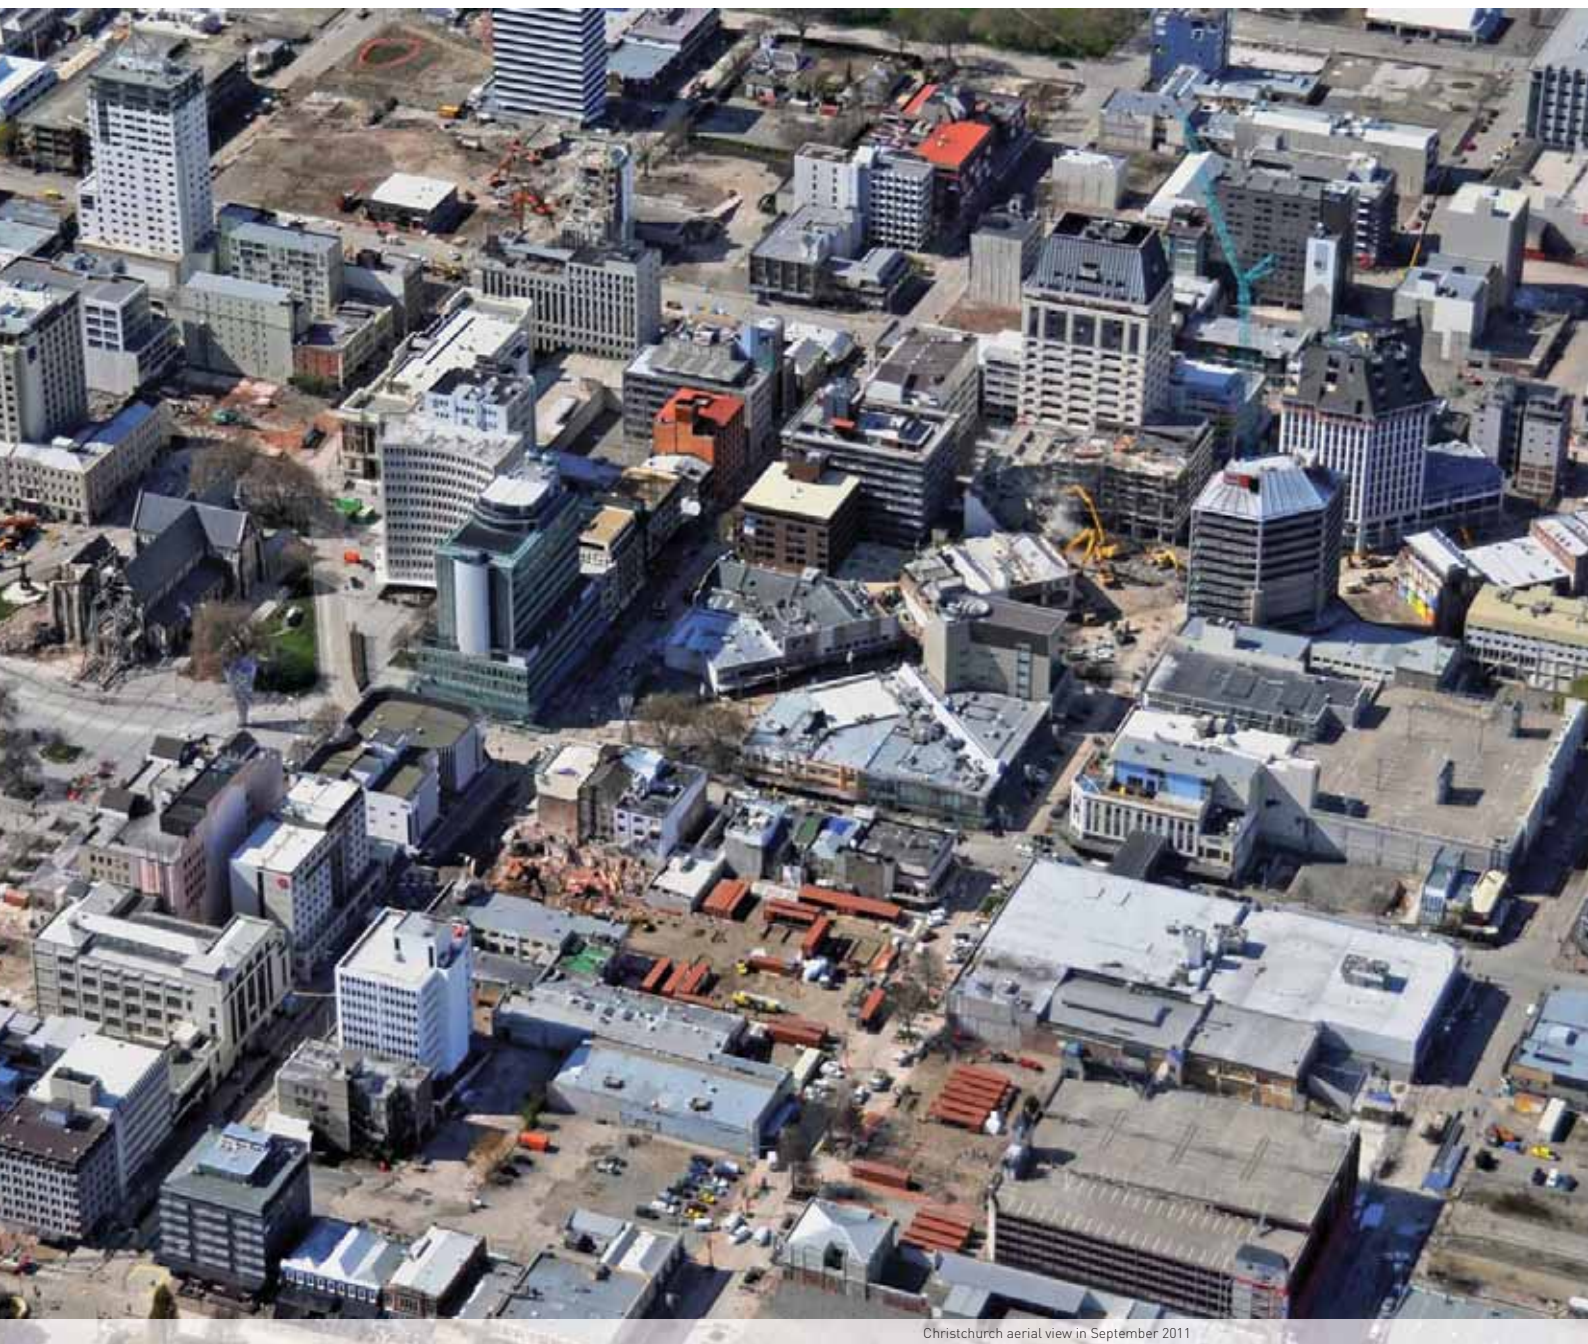
Christchurch aerial view in September 2011

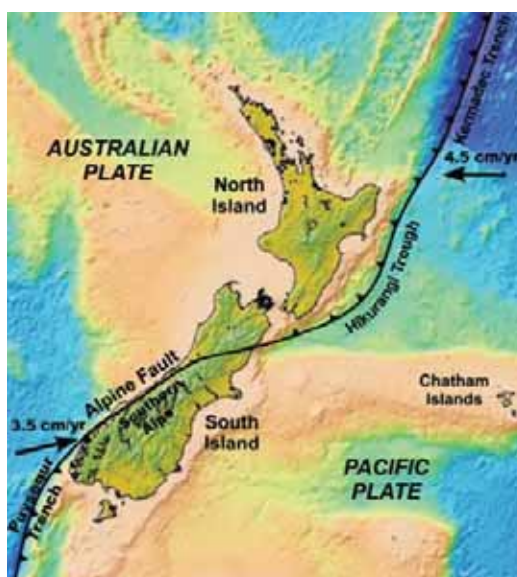
Figure 3: Plate tectonic setting of New Zealand. The westward pointing arrow in the upper, right corner shows movement of the Pacific Plate towards the Australian Plate in northern New Zealand, while the north-eastward pointing arrow in the lower left shows the movement of the Australian Plate relative to the Pacific Plate in southern New Zealand.

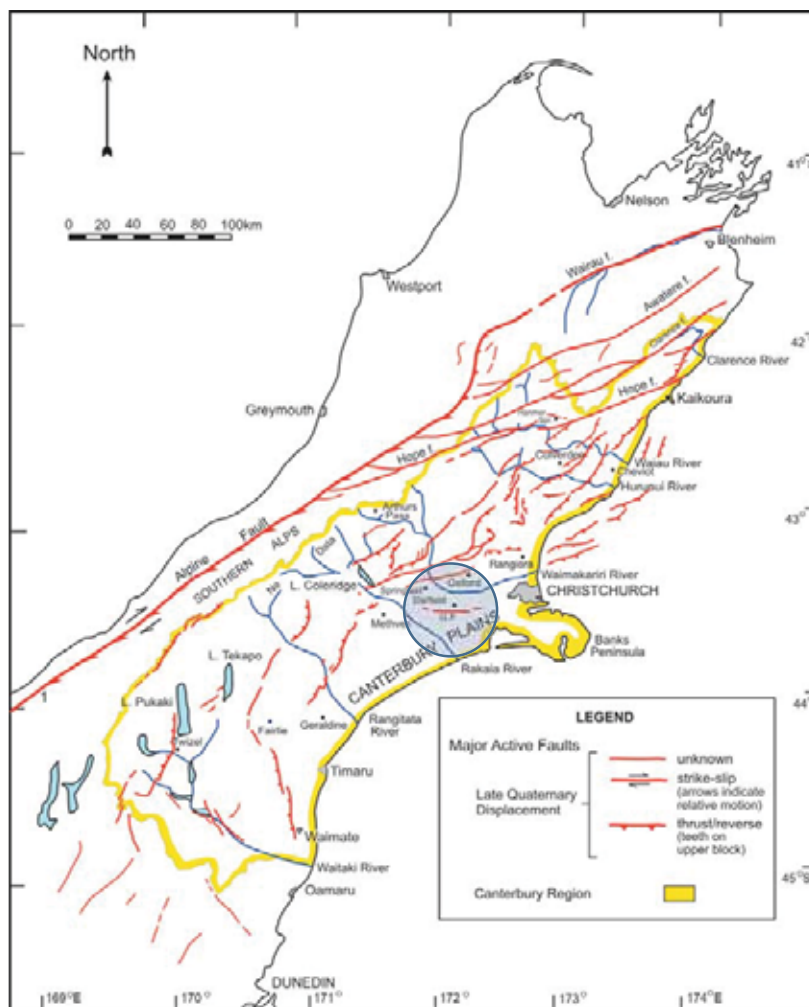
Figure 4: Map of the known active faults in the Canterbury region, including the recently formed Greendale fault (G.F.). Figure modified from Pettinga et al. (1998).

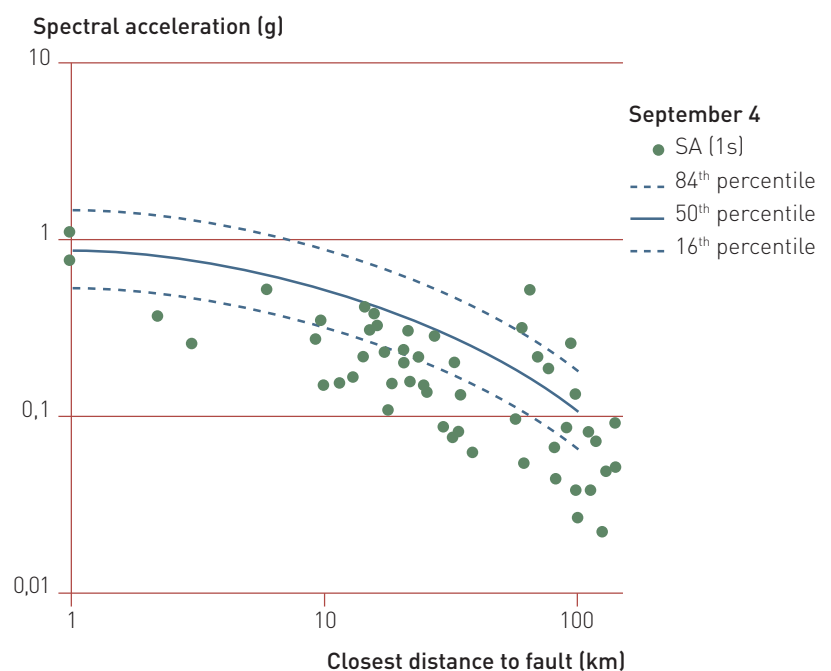
(McVerry 2006; Figure 6), the principal model underpinning the National Building Code. The values observed were similar to the ones predicted by that model for waves with periods of 1.0 second which are important for building design codes, and for deep or very soft soils (attenuation is different for rock or soft soils). These accelerations were generally close to the ones design level in central Christchurch (0.3g), but exceeded the design level in the epicentral region. Maximum horizontal and vertical ground accelerations in the Christchurch city area were recorded in numerous seismographs and are shown on Figure 7. While accelerations are mainly small (all are <1g and most are < 0.3g), unusually high motions for short period waves were observed in a suburb to the south of the city (Figure 7A). Those higher accelerations could be due to amplification by local soft shallow soils and basin structure (the depth and changes in depth of the sedimentary basin can affect wave amplification).

Figure 6: Observed ground accelerations (for waves of 1.0 second period) during the Darfield earthquake (green circles) compared to those predicted from the national attenuation model for deep or very soft soils (solid blue line; McVerry et al., 2006) at different distances (km) from the earthquake epicentre.

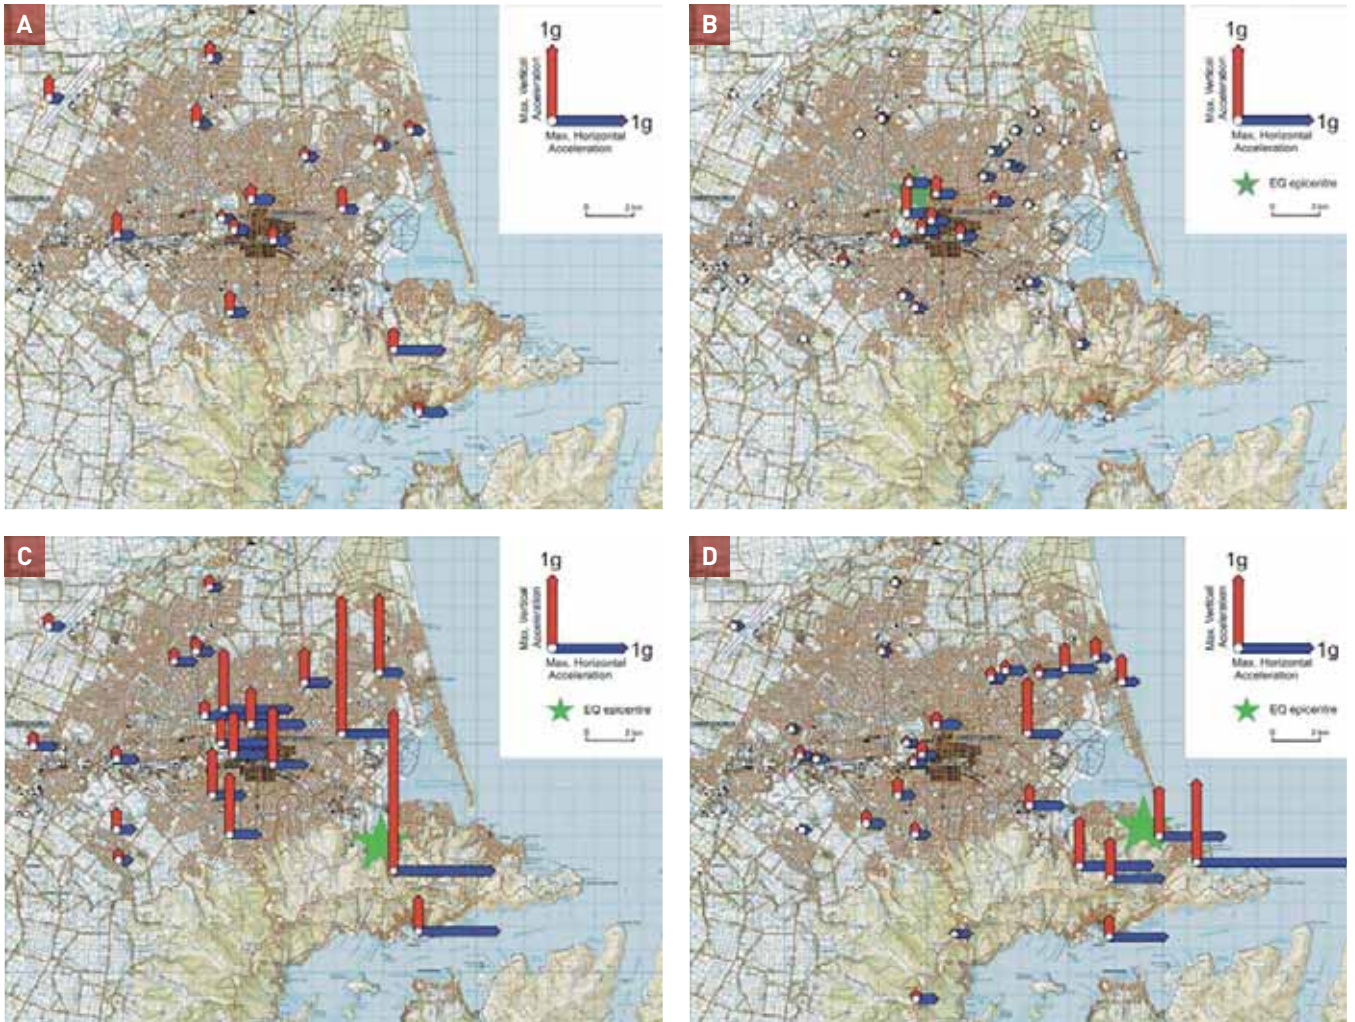
Figure 7: Maximum horizontal and vertical acceleration recorded during the 4th Sept. Darfield earthquake (A), 26th Dec. “Boxing Day Mw 4.7 earthquake” (B), 22nd Feb. Christchurch earthquake (C), and 13th June earthquake from GeoNet stations and temporary low-cost accelerometers (Quake-Catcher Network) (D).

Ground motions in Christchurch city were extremely high during the February event, reaching 2.2 times the Earth’s gravity (g) near the epicentre and up to 0.8 g in the CBD (Figure 7C). In areas close to the fault (less than 5 km away) horizontal accelerations were stronger in the Christchurch event than the Darfield main shock (Kaiser et al. 2011; Cousins & McVerry 2010).

The accelerations recorded during the 22nd February event were larger than those used in the New Zealand design standard for ‘normal use’ structures (average interval of 500 years), that is for building design (Webb et al., 2011). A number of factors are thought to have contributed to the high accelerations experienced in Christchurch city during the 22 February event (Fry et al. 2011a; Reyners 2011; Webb et al. 2011), including close proximity and shallow depth of epicentre, high stress drop (that is, a high energy event), and directivity of the fault rupture towards the city.

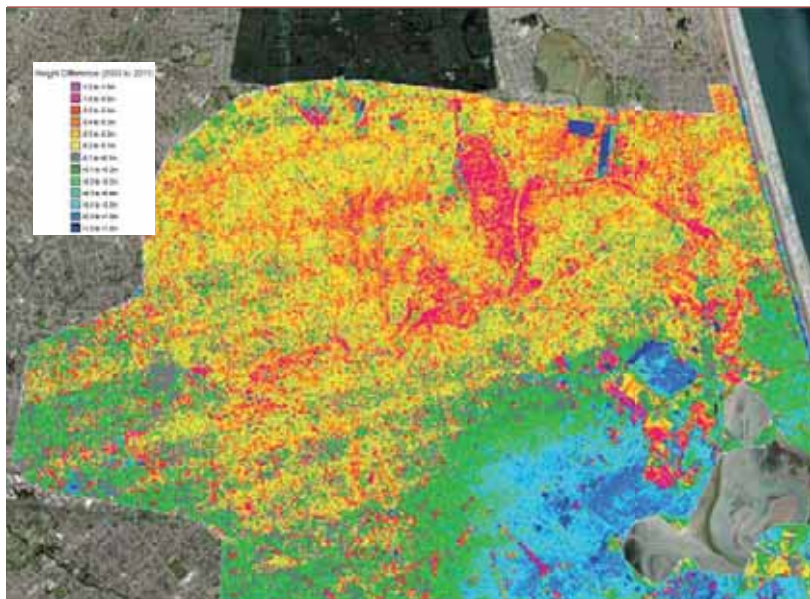
Figure 9: LIDAR image showing cumulative land elevation differences resulting largely from tectonic deformation, lateral spreading, and removal of liquefaction deposits as a consequence of the Darfield (minor impact), and Christchurch earthquakes (major impact). Note the uplift in the estuary area in the southeast quadrant and general subsidence with localised major differences in the northern half of the scene. The rectangular blue area showing uplift north of the estuary is a stockpile of liquefaction derived sediment removed from the eastern suburbs. (Image courtesy NZ Aerial Mapping Ltd).

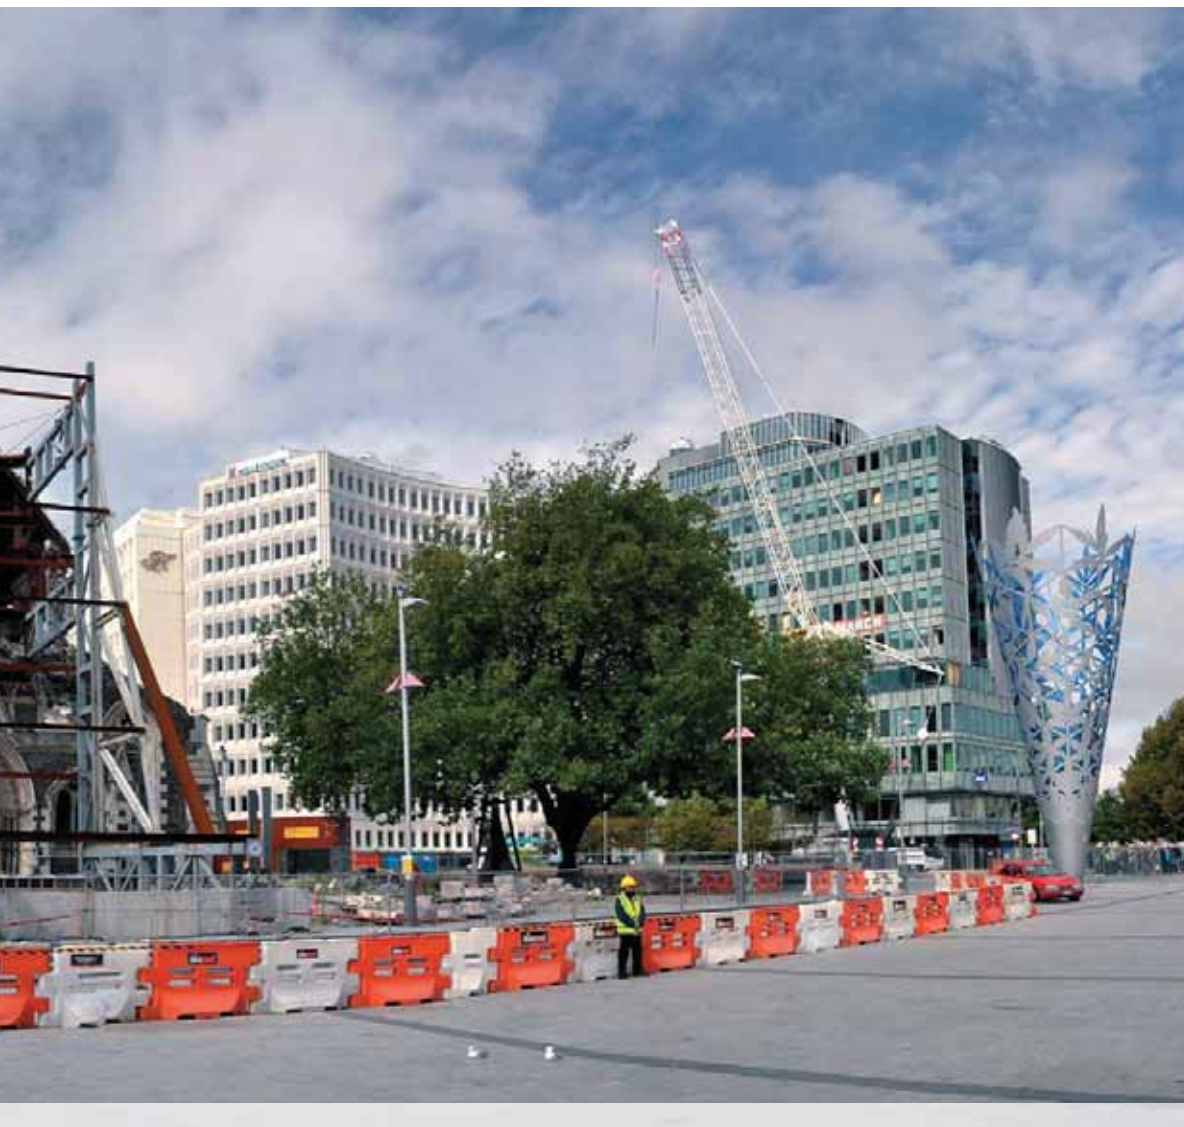
Socio-economic impacts have occurred because of the lack of functionality of commercial buildings even though the structure has performed well
